**Home Inspection Report**  
**Sample Rd.**  
**2019-300**  
Inspector *Todd Gandee*,  
Tennessee License 794

Date: April 22, 2021                      Time: 1 pm  
Weather: Mostly sunny. 78 degrees. Soil conditions: Dry.  
Parties present: Buyer and agent. Home was occupied.  
The front of the house faces: North

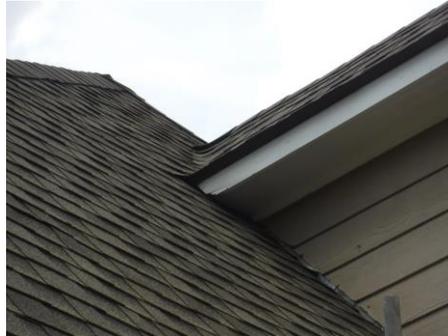
**Photo 1**

- 2. Exterior: Brick veneer and composite wood siding.**
  - a. Rotten wood noted in the following locations:
    - i. Noted at the fascia board at the dormer on the north side of the home. Photo 1
    - ii. Noted at the cornice/ rake board at the south side dormer. Photo 2
    - iii. Noted at the vertical trim at a couple locations at the breakfast room windows. Photo 3, 4  
Suggest replacing all rotten wood to prevent further damage/ deterioration.
  - b. The dryer vent termination point was located behind the a/c condenser. This condition will vent dryer lint at the condenser during operation of the clothes dryer. Client may wish to extend vent away from condenser as needed. Photo 5

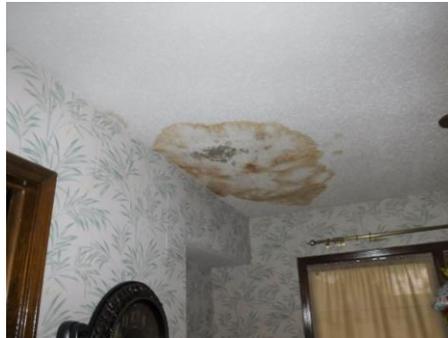
**Photo 6**

- 3. Roofing: Asphalt composition shingles. The roof was walked upon.**
- a. The roof was multiple layered and appeared to be older/ worn at several areas. Newer shingles were observed patched in as repair at a few locations. Noted for client's information.
  - b. A ceiling stain was observed in the breakfast room. The stain was tested and was dry at the time of the inspection. The roofing above this area appeared to have been recently replaced. Noted for client's information.
- Photo 6

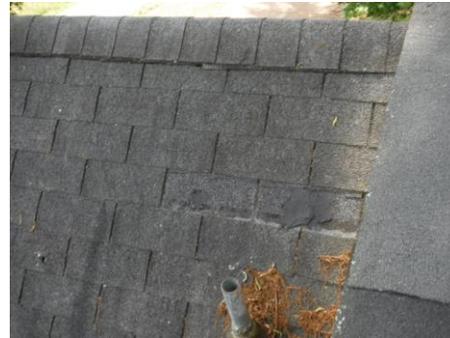
**Photo 7**

- c. Cracked/ missing shingles were observed on the west side of the roof next to the north roof/ siding transition. Suggest repair by a qualified roofing contractor. Photo 7

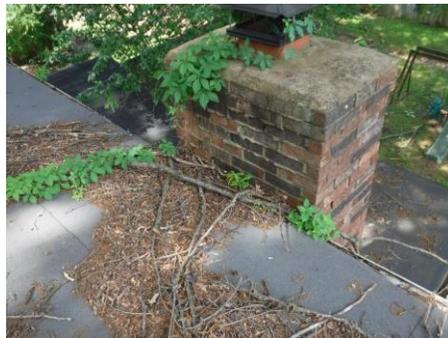
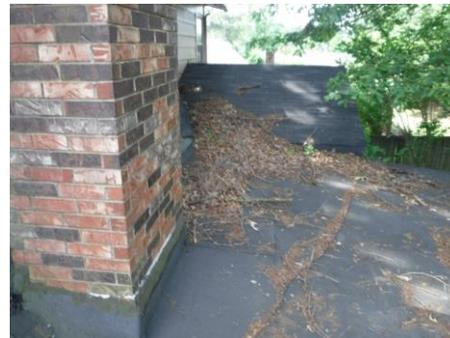
- d. Leaves and debris were observed at several areas on the roof. Suggest clearing off for further review of covered areas and to ensure roof water drains properly. Example photo 8, 9

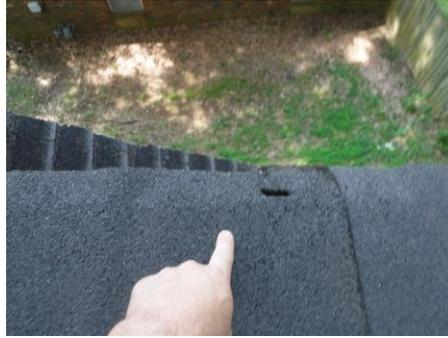
- e. A hole was observed in the 2<sup>nd</sup> story rolled roofing material at the south end of the roof. Suggest repair by a qualified roofing contractor. Photo 10

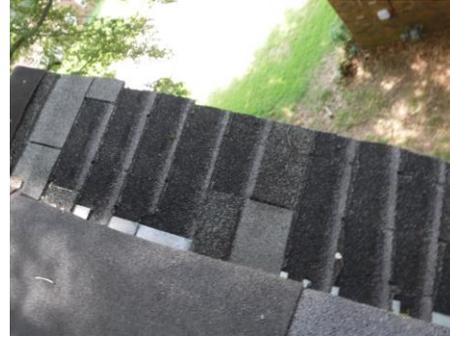
- f. Shingles had been removed leaving exposed nails at the south end of the roof. This condition may allow water to penetrate around the nails. Suggest repair/ shingle replacement by a qualified roofing contractor. Photo 11

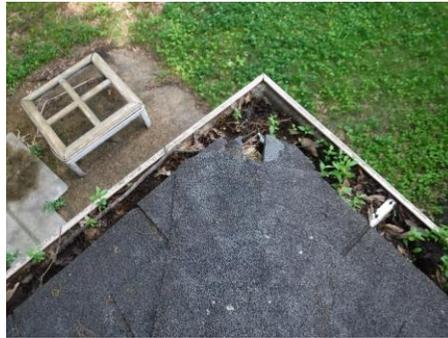
- g. A torn shingle was observed at the northwest corner of the breakfast room. Suggest repair by a qualified roofing contractor to prevent further damage/ deterioration to the exposed fascia boards. Photo 12

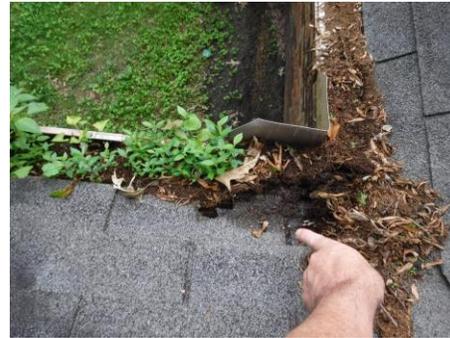
- h. A torn shingle was noted at the starter course at the roof valley by the back porch. Suggest repair by a qualified roofing contractor to prevent further damage/ deterioration to the exposed fascia boards. Photo 13

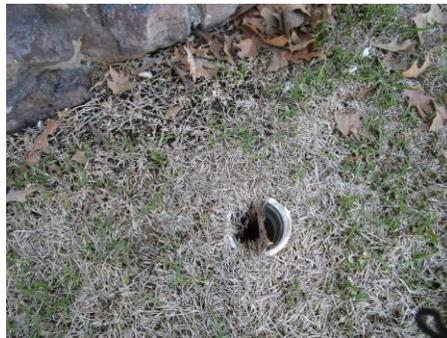
- c. A cap was missing at a plumbing cleanout location in the front yard. Suggest repair/ installing cap. Photo 16
- d. The hot supply handle in the hall bathroom tub leaked during operation. Suggest maintenance/ repair. Photo 17

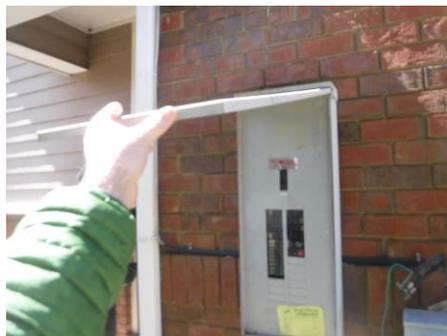
- a. Serviceable The electrical panel cover was designed to lift and stay in place for access. The cover would not remain in the open position when tested. Suggest review/ repair. Photo 18
- b. The stress relief clamp or romex connector was not installed at the electrical entrance to the disposal. Suggest installation as needed to prevent damage to the wires and/ or splices. Photo 19
- c. Several lighting fixtures (front porch; microwave surface light; storage room) were inoperable at the time of inspection. This condition generally indicates missing or burnt bulbs. Suggest client verify the operation of all lighting fixtures prior to closing.

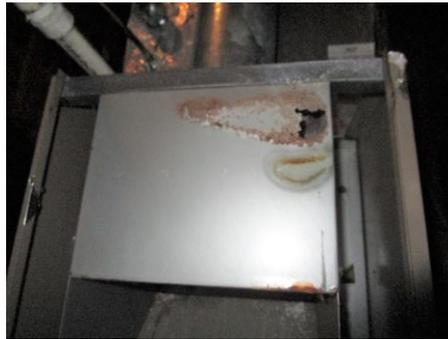
Photo 20

- 6. Heating: Gas, forced air system. 2 x low-efficiency models with standing pilots (original).**
- a. The furnaces were older models and due to age may have a limited remaining life expectancy. Noted for client's information.
  - b. A hole was observed at the front of the upstairs furnace between the burner chambers and the vent pipe (photo 20). Suggest further review by a qualified HVAC technician.
  - c. A crack was observed in the heat exchanger in the downstairs furnace. This condition will allow articles of combustion to escape into the home, posing a significant safety hazard. Suggest further review by a qualified HVAC technician for replacement as needed. Photo 21

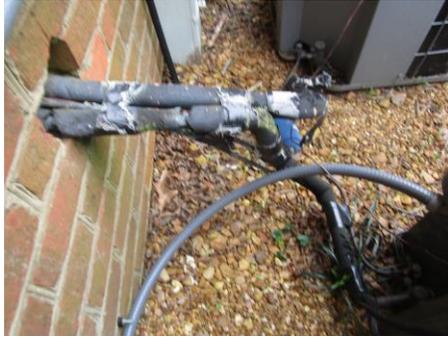
- 7. Central and through wall Air Conditioning: Electric, split systems (evaporators 2001 and 2006; condensers 2011 and non-legible sticker).**
- a. As most manufacturers warn against operating air conditioners when the outside air is below sixty-five degrees, this system was not operated. Suggest client verify this system's operation when the temperature allows.
  - b. Insulation around the refrigerant lines was deteriorated at the condensers. Suggest maintenance/ repairs as needed. Photo 22
  - c. The fins around one of the condensing units were dirty. Suggest a service call by a qualified HVAC technician for cleaning as needed. Photo 23
  - d. The breaker for the condenser which had been replaced was not the correct rating for the unit. The unit was rated for maximum 30-amp breaker and the installed breaker was 50-amp. Suggest replacing as needed. Photo 24

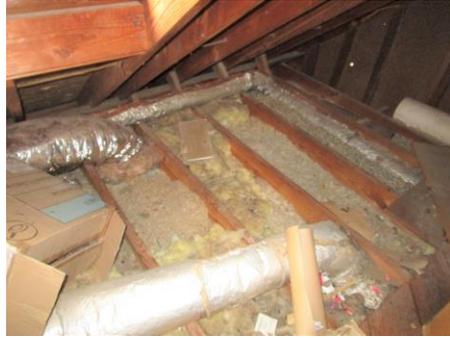
Photo 25

- a. Insulation was observed uneven in depth and missing at a few locations within the attic. Suggest repairs/ an even coverage as needed for energy efficiency. Example photo 25
- b. The gable vent at the north end of the attic was partially covered with plastic. The screen at the vent at the south end of the attic was damaged/ torn. Generally, these are covered with screen to prevent animal/ pest entry. Suggest review/ repairs. Photo 26, 27

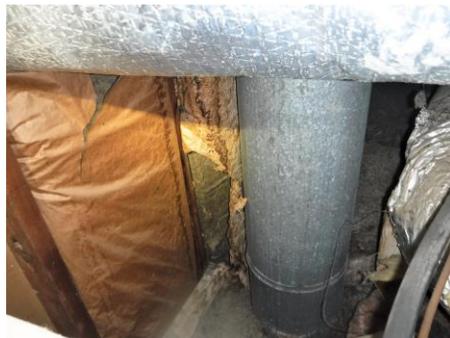
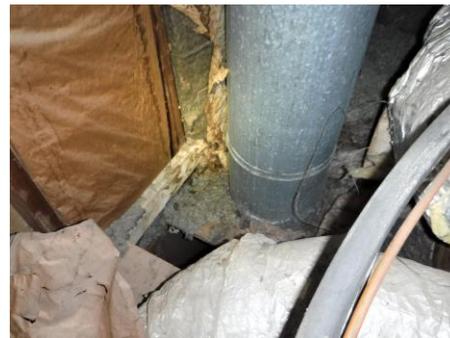
- a. Insulation was observed in contact with the fireplace flue in the attic. There is a two-inch clearance requirement as a fire safety precaution. Suggest review/ repair. Photo 14, 15
- b. An excessive amount of creosote was noted within the fireplace flue. Suggest a service call by a qualified chimney sweep for cleaning as a fire safety precaution.

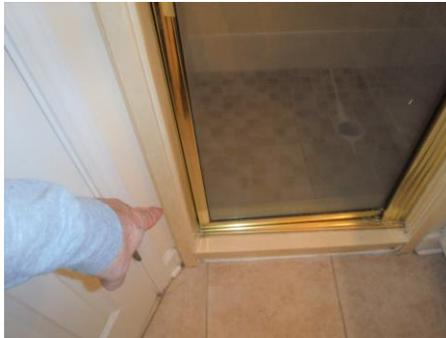
**Photo 30**

15. The master bathroom shower door was catching at the bottom when opened/ closed. Suggest maintenance/ repair as needed. Photo 30
16. Moisture damaged floor covering was observed in the kitchen in front of the refrigerator and in the entry hall by the front door. Noted for client's information.
